## **ASRF Australian Street Rod Federation - Technical Advisory Committee Advice sheet 3/16 Warning -- Steering arm failures on 37/48 Ford stub axles**

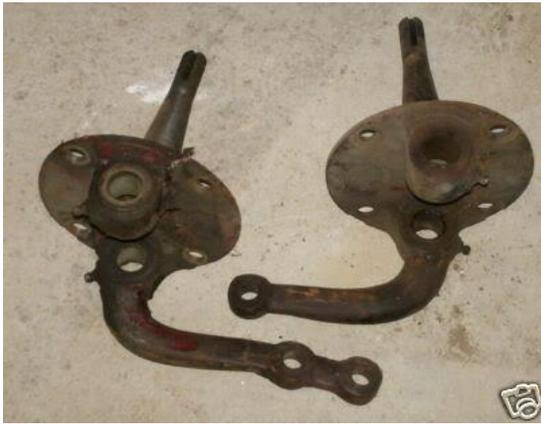
1930's / 40's type Ford Kingpin with forged in steering arm.

1/ The part in question is an original 1930's/40's Ford part, made from forged steel. The steering arm section is part of the stub axle attached at the kingpin base as part of the one-piece forging process. Ford made millions of these and they were quite satisfactory for the job at the time but are all now 75 + years old.

Therefore, it is highly recommended that if constructing a new street rod or restoring a Ford car that uses this part, a thorough profession crack test be made of this section as well as the king pin and wheel bearing areas. It is also advisable if a vehicle has been involved in an incident where any steering or suspension parts might be subjected to extreme loads they be examined and crack tested.

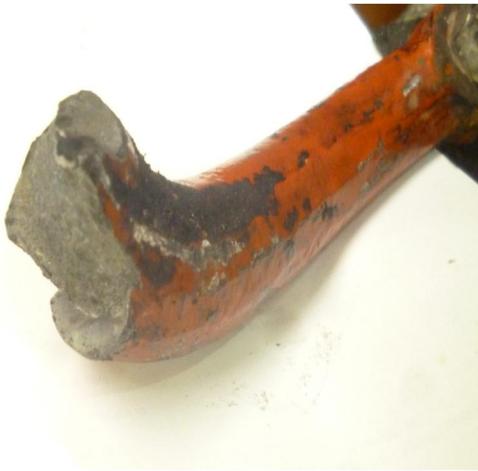
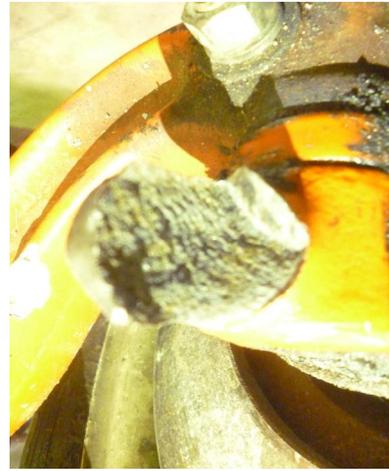
After examination of the wrecked car it was evident that failure and separation of the steering arm on the RH stub axle had caused the loss of steering, having broken off at the stub axle flange.

Above - Stub axle showing fatigue crack LH side, which has been present for many years, then recent impact broke it 3/4 through leaving only small section intact which later totally separated. Steering arm , lower section is old partial crack, centre part recent damage, top part held until failing on the day and causing loss of steering.
